This is my report on the wiring anomaly on my bike. My original suspicions have been confirmed along with a “Huh?” type of wiring error.

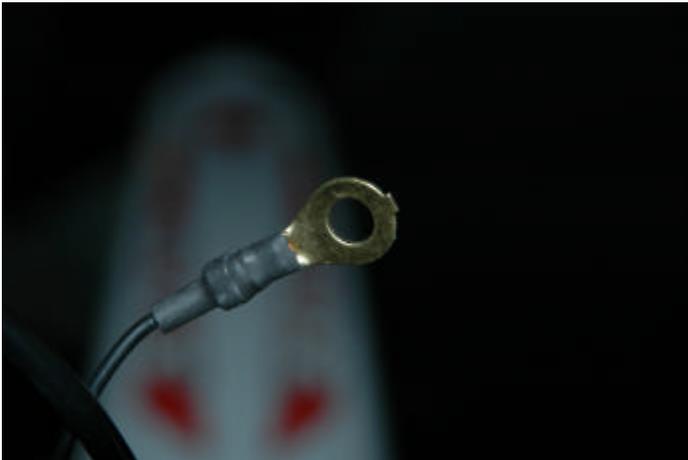
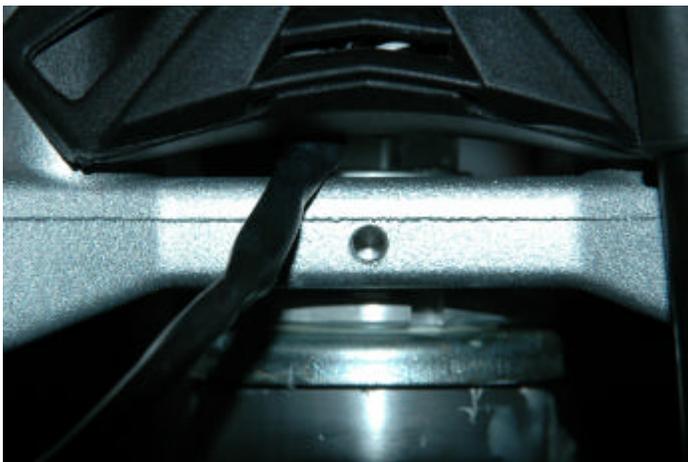
The first thing I noticed on removal of the headlamp assembly was the use of a “ground lug” captured by a screw that passes through the top headlamp screw hole into the top triple clamp I was immediately suspicious of this connection for two reasons. The head of the screw rests on the headlamp assembly insulating it from the ground lug and the lug rests on the surface of the triple clamp which is anodized aluminum. Anodized aluminum is formed of an aluminum oxide which is an insulator. I verified this by measuring the resistance of the surface of the clamp at the lug site. This means that the ground lug is relying on the surface contact of the screw threads against the inside surface of the

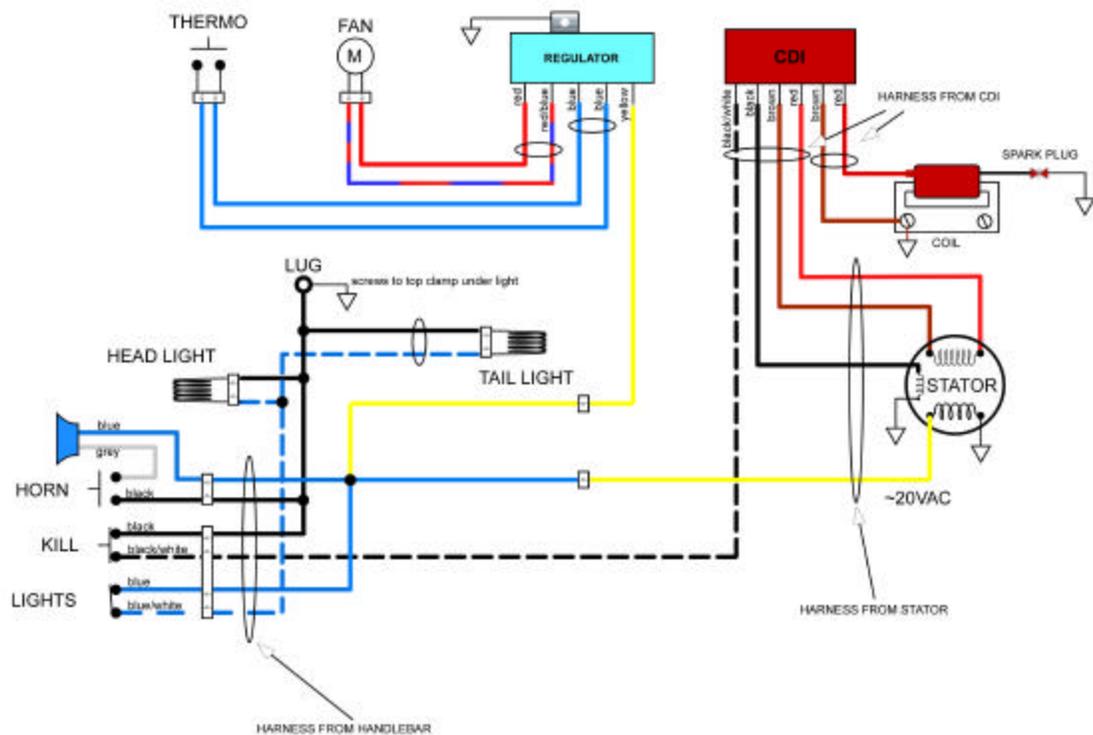
This illustration shows the actual factory wiring of my '08 270. Upon disassembling my wiring I made several critical discoveries. The first and most disturbing was that all grounding for the wiring to the handlebar cluster is achieved through a single ground lug mounted behind the headlight assembly top bolt. There are five black wires coming from a common splice at the bottom of the handlebar wiring harness that can be considered the reference ground. One of these is an ~18 gauge wire that goes back up the harness to the ground lug. The other four ~22 gauge wires are headlight, tail light, horn and kill switch ground. The other wiring oddities I discovered were the lighting system is now driven directly from the lighting coil and there is now four wires coming from the stator assembly as opposed to the previous versions where six wires came from the stator giving access to both sides of each coil (lighting, ignition, trigger). This means that there is either some common grounding through one of the wires or Beta is using the engine case as a ground connection.

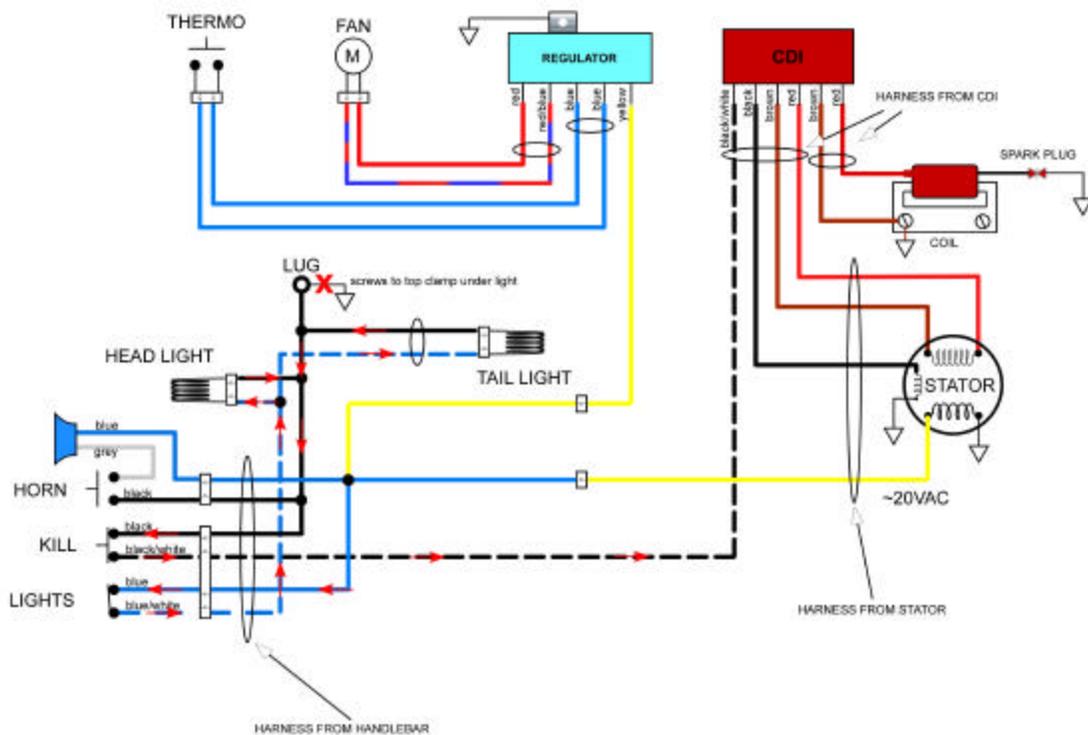
This illustration shows what I believe is a critical flaw responsible for the majority of failed ignition systems in the past and points to a modification that should be made by any owner who's kill switch ground is wired through the ground lug under the headlamp. As observed on my bike there is a possibility the ground lug under the headlight assembly will suffer a high resistance connection to ground. On a bike with the wiring feeding the ~8-20VAC lighting current to the control cluster and the kill switch tied to the ground lug there is a clear path for the lighting current through the light switch and the headlamp/tail lamp bulbs back through the kill switch into the CDI/stator coil.

Beta appears to have been aware of this problem on the later bikes that have a 1N4007 diode in the kill switch circuit to block this current from returning through the ignition coil. For the later bikes which ran the lighting system off the 12V regulator this effectively protects the ignition system from being damaged by the lighting current although it doesn't address the fundamental problem. For the newest bikes that run the lighting off the AC output of the lighting coil directly the effectiveness of the diode is dubious and has been left out of the circuit anyway.

This explains why a bike could run for quite a few months (years) without a problem and suddenly die. If the kill switch is never used while the lights are on there is no possibility of the lighting current finding its way into the CDI unit. Also if there is a good connection through the ground lug then the lighting and ignition systems remain isolated

as any differential current between the two systems is shunted to ground. If after a few months or years the ground lug loses contact or the engine is running wide open after a fall then the current from the lighting system could be sufficient to damage either the CDI box or even the thin wire on the trigger coil of the stator.

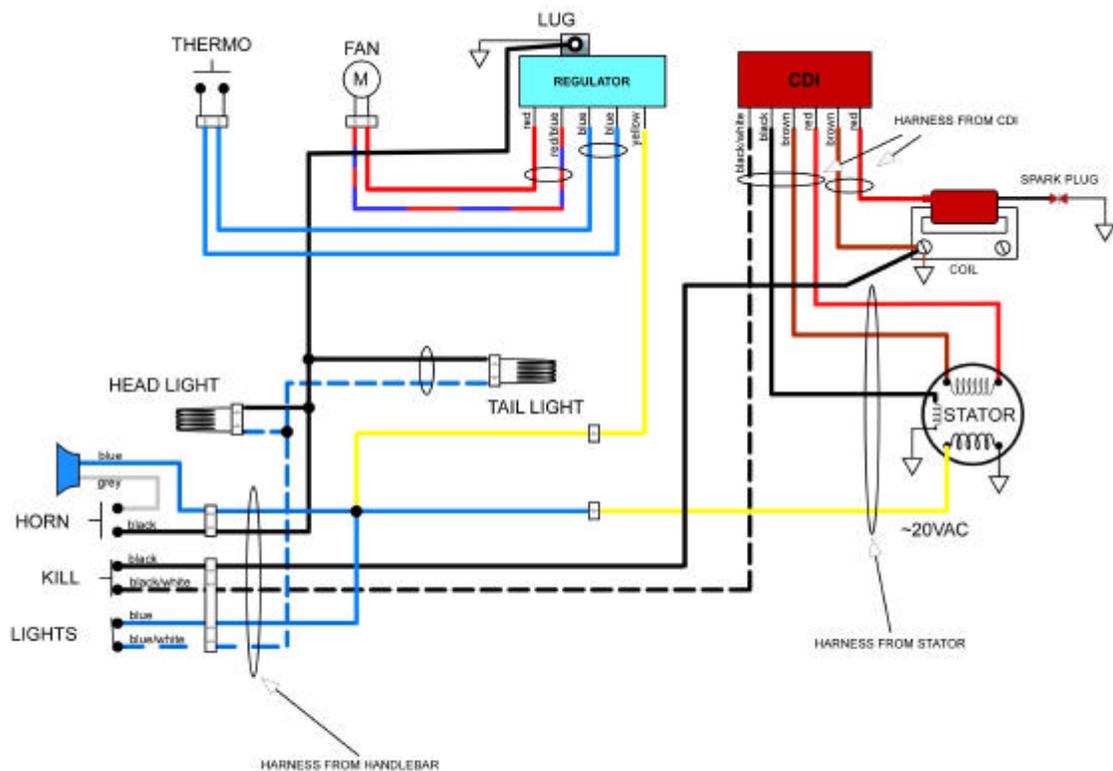
One thing I should point out is my drawing of the stator grounding is a supposition. There are three possible grounding configurations that will work but it makes no difference as far as the ignition failures are concerned.

This illustration shows the correct way to connect the grounds for lighting and ignition kill circuit. The first and simplest solution is to run a separate ground wire for your kill switch back down through the wiring harness to a point on the chassis. My preferred point is the ground reference at the ignition coil. On the '08 this can be done by taking off the tank cover and finding the end of the harness tubing. Remove the electrical tape. You'll see a bunch of black wires connected together. You may have to pull the bundle out of the harness tubing as on mine it was stuffed up into the tubing. By pulling wires and observing the wires at the top of the harness it's easy to figure out which goes to the kill switch. This is the wire that needs to be removed from the big splice and connected to

the top screw of the ignition coil. If you use a good quality crimp connector it's going to be much better than relying on the connection through the steering head bearings to kill a runaway engine. If you're feeling particularly gung ho about doing this the right way the next step is to pull the exhaust header and radiator out and find the frame tab the regulator is mounted to. Remove the 10mm nut and take a little sandpaper and clean off the tab and mounting plate of the regulator. Now find the ground lug behind the headlight and cut it off and fish the ~18 gauge wire back down through the harness, cut to length and put a new circular lug on appropriate to the bolt that mounts the regulator to the frame. Remount the regulator putting the new ground lug under the 10mm nut. Put radiator and pipe back on and go have fun.
