# Beta Debug

## The problem:

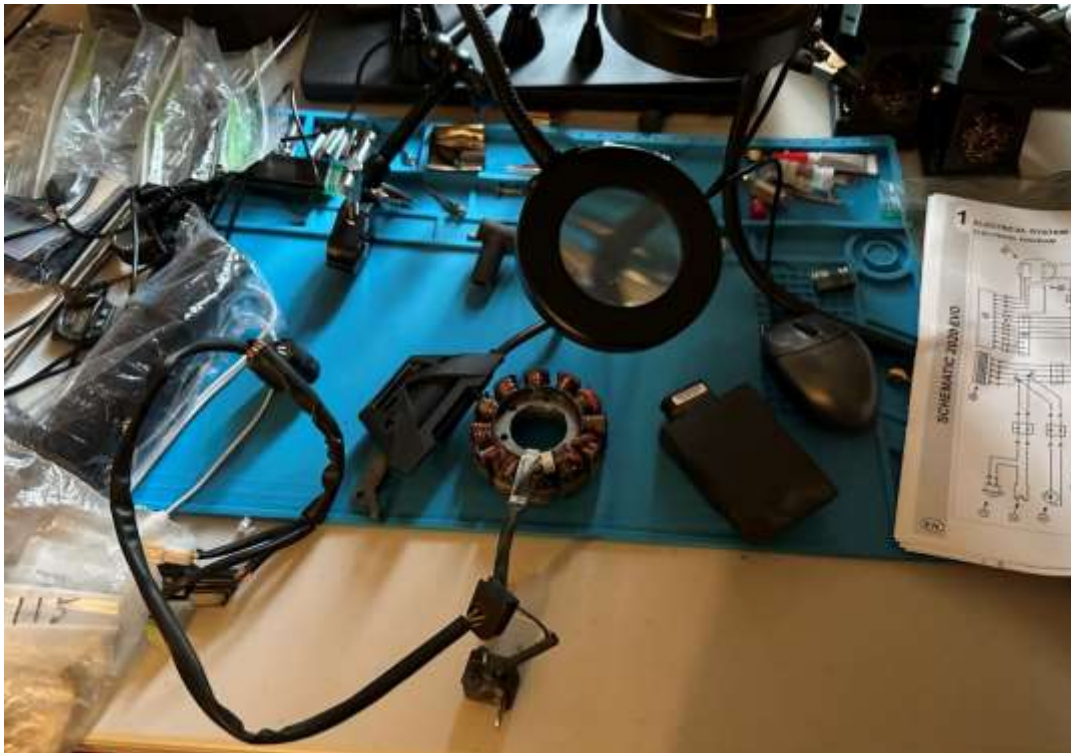
Figure 5 Ignition coil, Stator W/harness and CDI (Along with bags of carb jets, microscope lens and assorted other debris. As still lifes go it's no Vermeer)

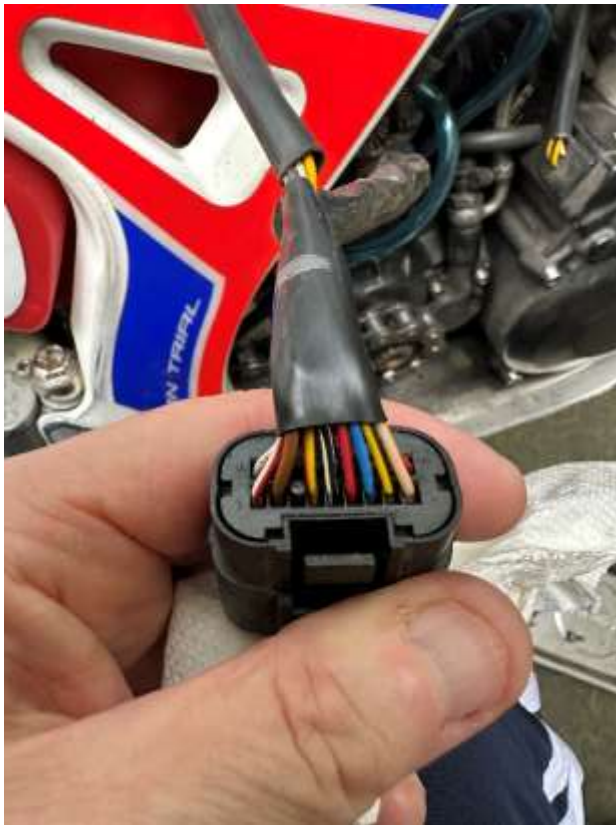
Figure 7 CDI connector,  
Note Red/White high voltage wire to ignition coil and Brown wire to ground nexus. Blue and Red wires are the CDI charging wires from the Stator. White/Black wire is the Kill Switch and Yellow/Red wire is the mapping switch.

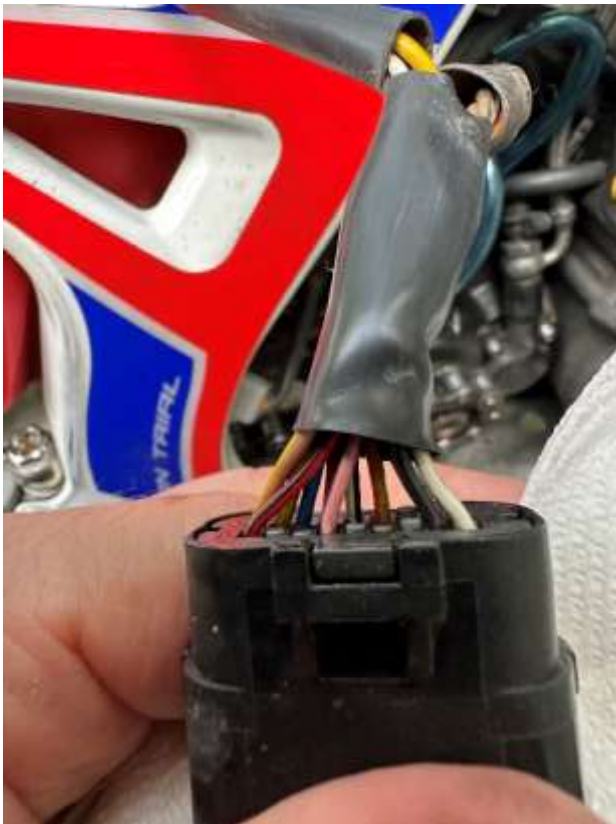
Figure 8 CDI connector,  
Note Black and White wires to trigger sensor on Stator. Red/Black wire is 12V from regulator.

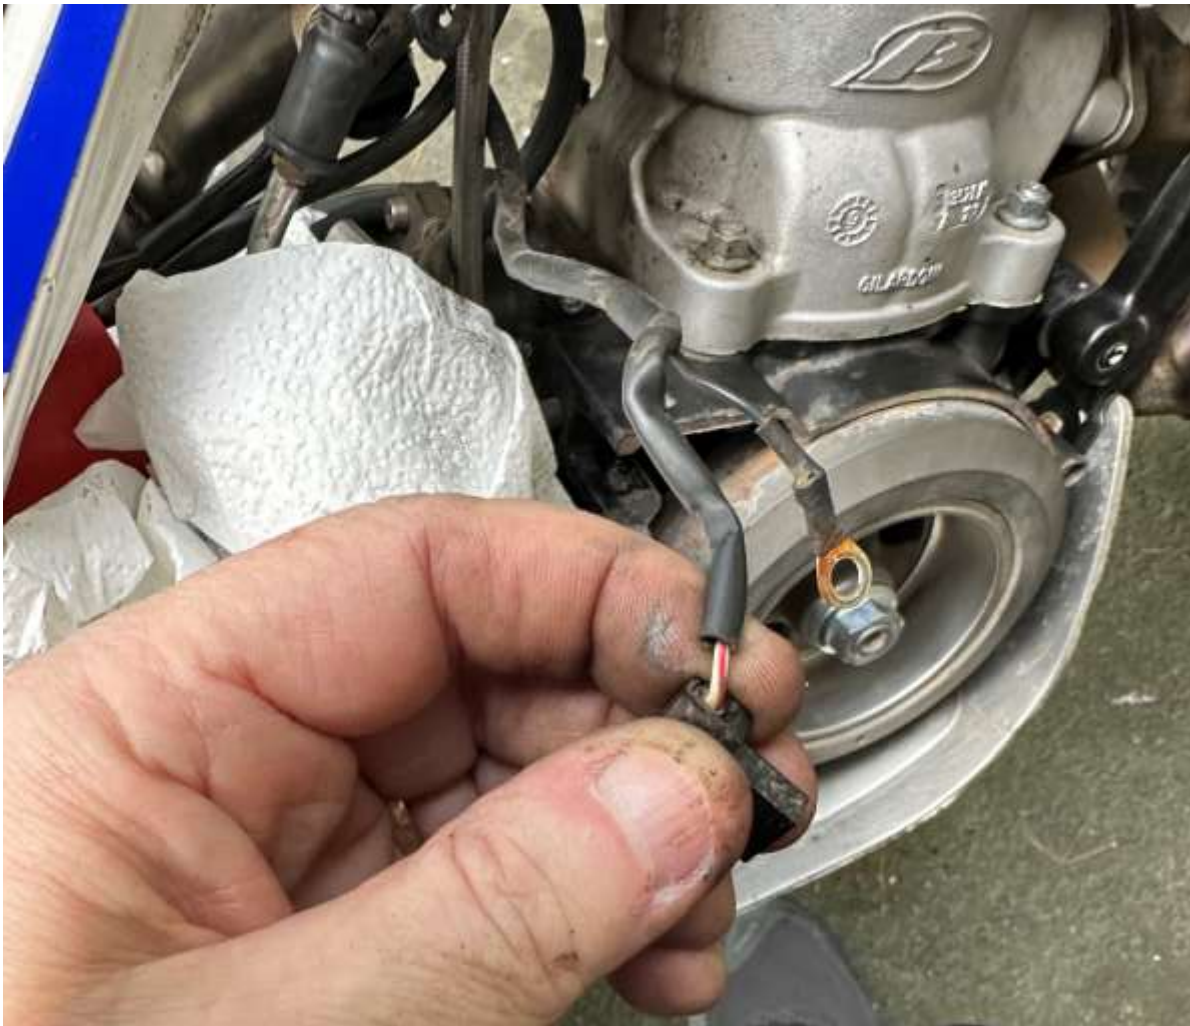
The ignition coil is a common terminal type where the two windings share a common connection. There is no terminal for the coil ground relying on the mechanical connection of a wire lug secured to one of the mounting screws through the coils laminated core. There may also be a secondary ground connection through the mounting bracket to the engine though this may not be as secure a connection owing to the mounting to painted or oxidized points on the engine or frame.

*Figure 9 These are the ignition coil connections. High voltage red/white wire to spade lug and black wire to coil frame from ground nexus.*

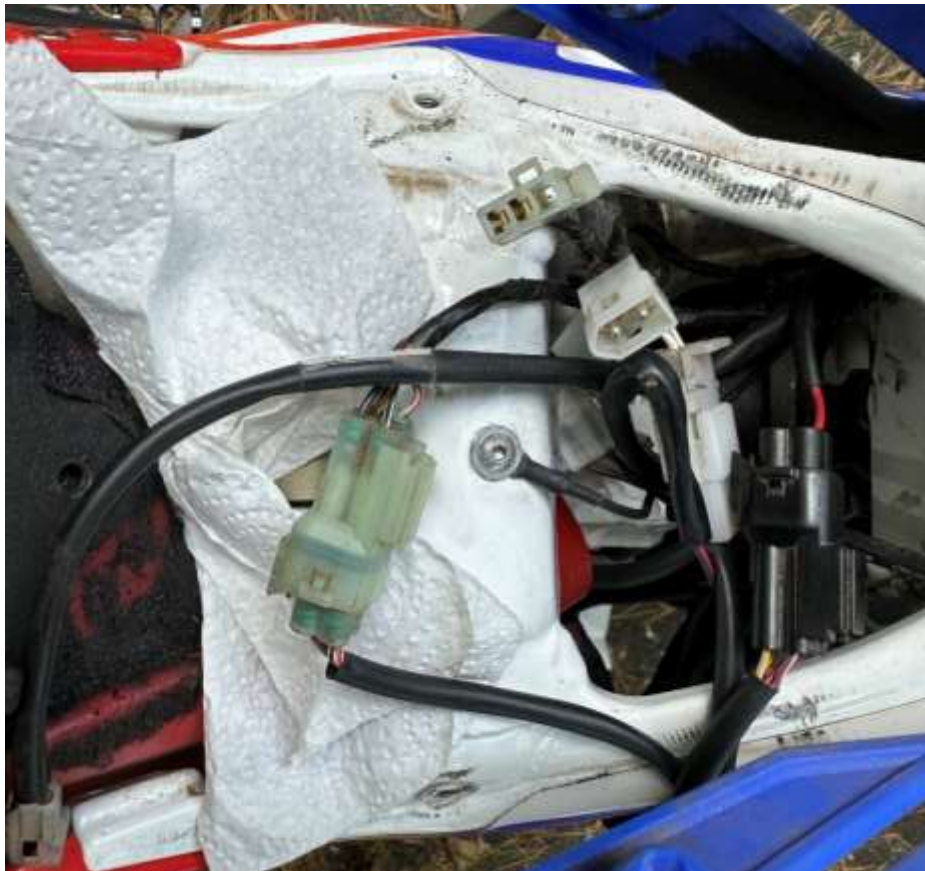
As noted there is a ground nexus in the wiring harness that provides the reference point for all the electrics on the motorcycle. This is different than the classical method of grounding a vehicle electrical system through the frame/engine. There is one electrical component that requires ground through the engine though and that may be the weak point of how Beta has wired this bike. The spark plug return current requires a hard ground through the cylinder head. How this current gets back to the common point of the ignition coil is what bugs me. If we assume the mounting bracket of the ignition coil is not making stellar contact with the frame/engine case, then the entire return path for the spark plug is through a wire that comes from the ground nexus. This wire can be found under the seat connected to a single screw into the frame that also mounts the support bracket for the CDI module. This is not ideal as the frame is painted in this area and you are relying on contact through a small screw that may develop a higher than expected resistance. The other factor to consider is the inductance of the return path. The spark is a fast rise time high voltage/current signal. The return current has to pass through the spark plug shell to the cylinder head to the cylinder to the engine cases to the frame to the ground screw through the ground wire to the ground nexus to a wire connected to lug bolted to the ignition coil mount. Not a very straight forward path for a big pulse of current. In automotive systems, engines and frames are connected with working big wires and the assumption is they share a hard ground and it's never thought of again. That's an assumption that may not be valid the way Beta has wired the EVO.

*Figure 10 This is the return path for the spark plug current. It may not be adequate.*

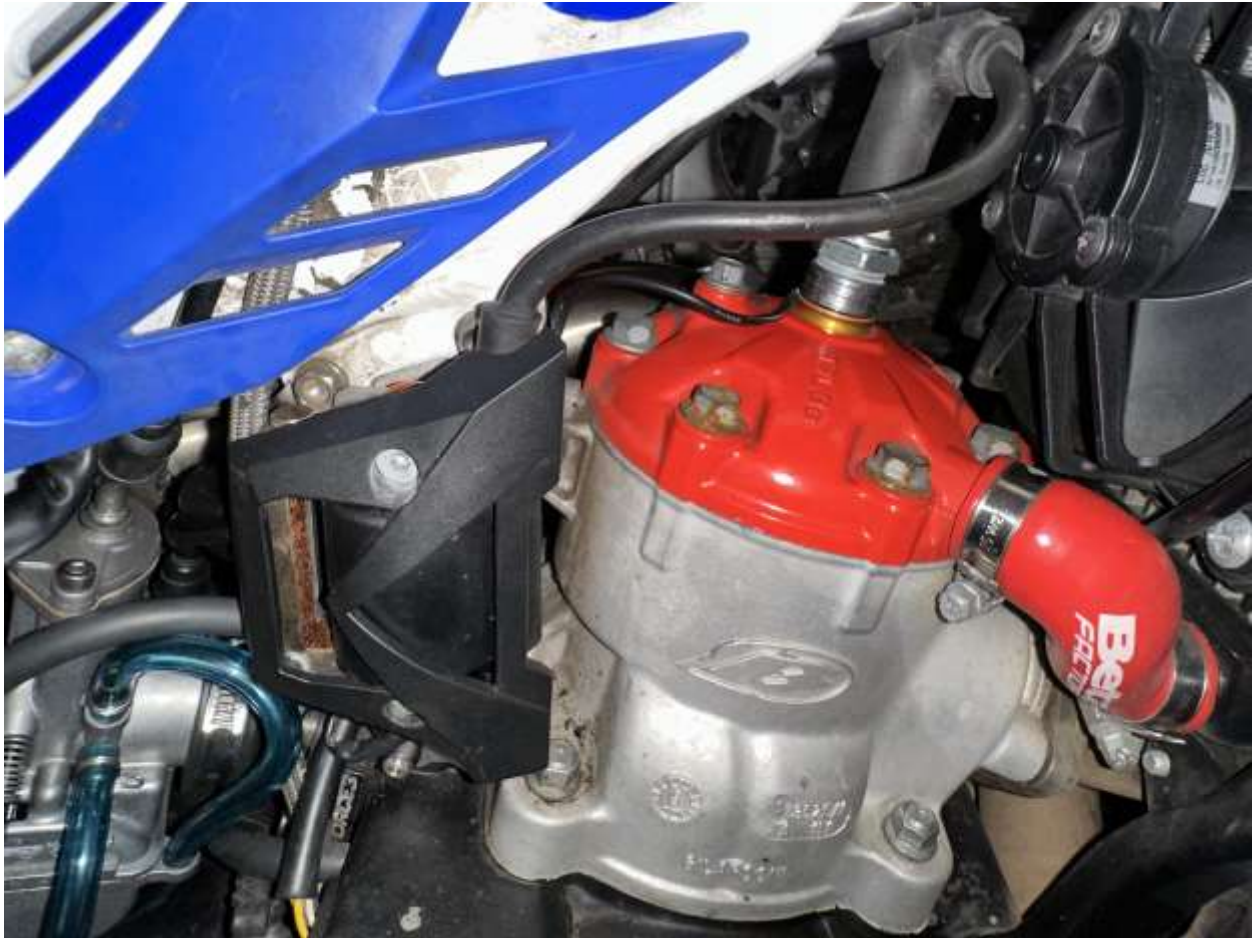
I have an S3 low compression head on my bike. It has a lovely gold anodized color. It didn't occur to me until I was trying to measure the continuity between the spark plug shell and the ground reference of the electrical system that anodized aluminum is an insulator. I'm reading ~150 Ohms between the cylinder and the spark plug shell simply because it is anodized. This may not be significant because the spark plug cap itself has a 5k Ohm resistance to minimize electrical noise (by slowing the rise time of the spark current) but it's something I noticed so I'm just putting it out there. I intend to pull the head off my bike and sand off the anodizing where the water jacket contacts the top of the combustion chamber just to make sure there is a good contact. I can then move the coil ground wire to one of the cylinder lugs.

*Figure 11 Temporary ground wire connected from spark plug base to ignition coil frame using a copper washer. This will be replaced with a wire from the cylinder base lug.*

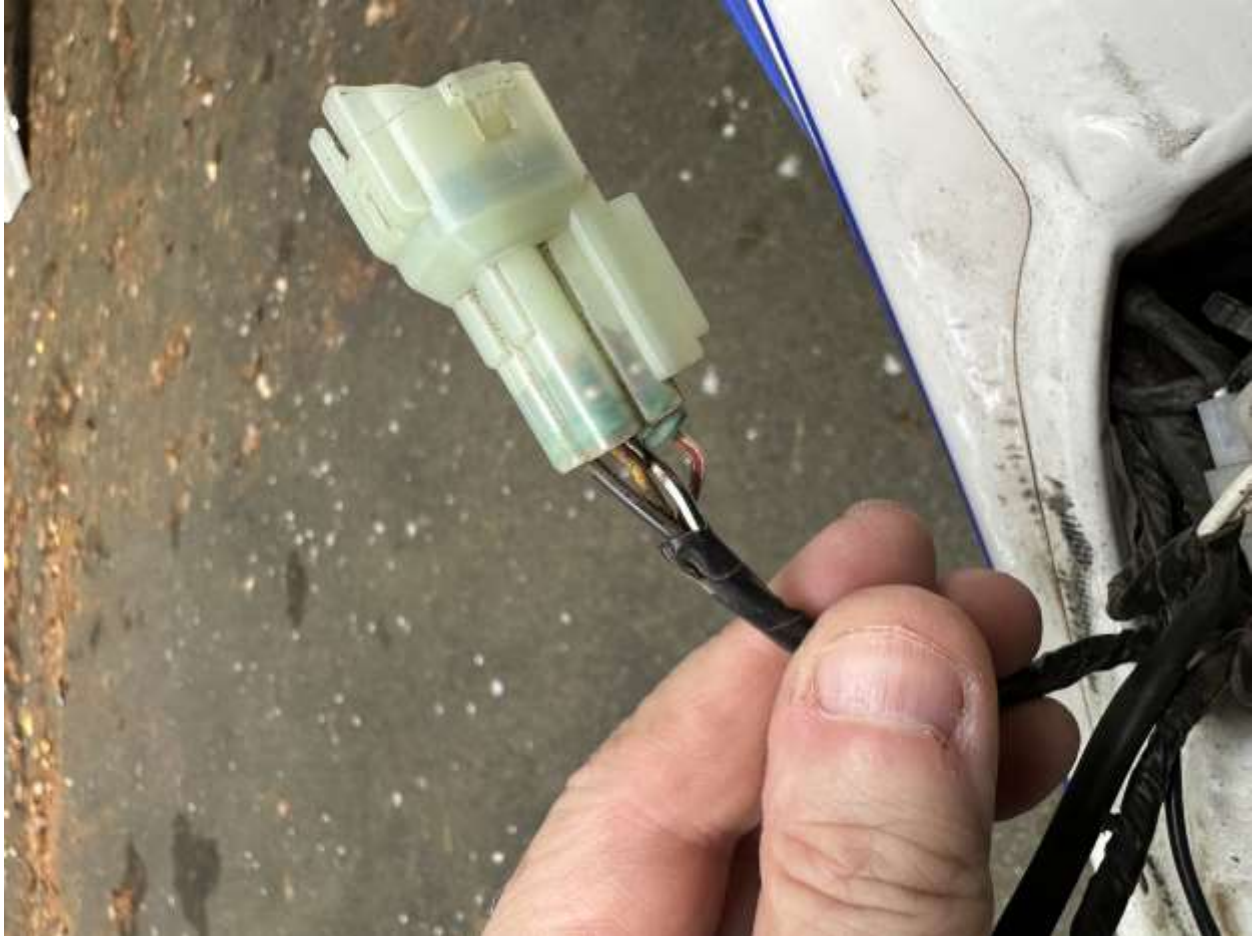
Noticed this little detail while inspecting other pictures. This is the seal on the backside of the connector for the high voltage wire that goes to the coil. Probably irrelevant but noted.
