# Beta Debug

## The problem:

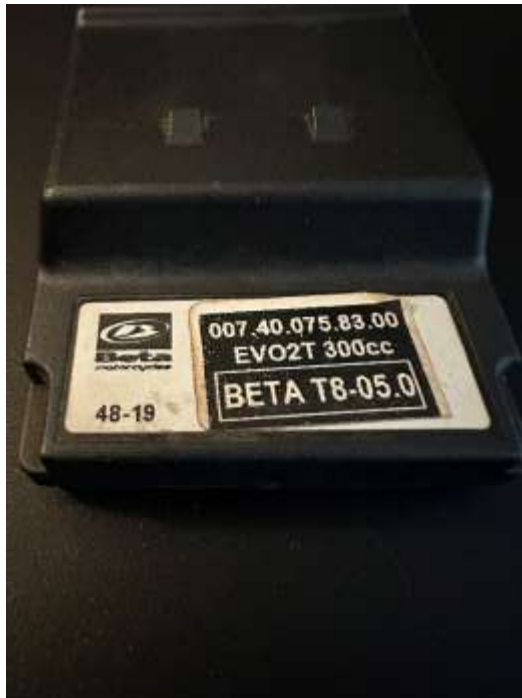
Figure 3 Part number for programmed 300 2T Factory module.

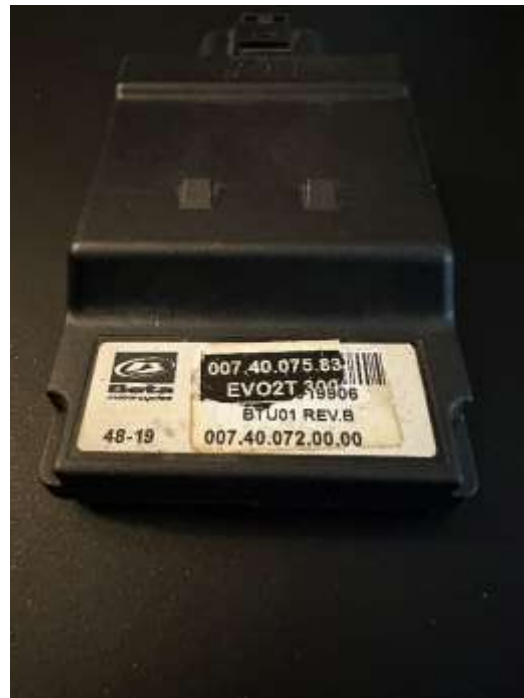
Figure 4 Number for unprogrammed module

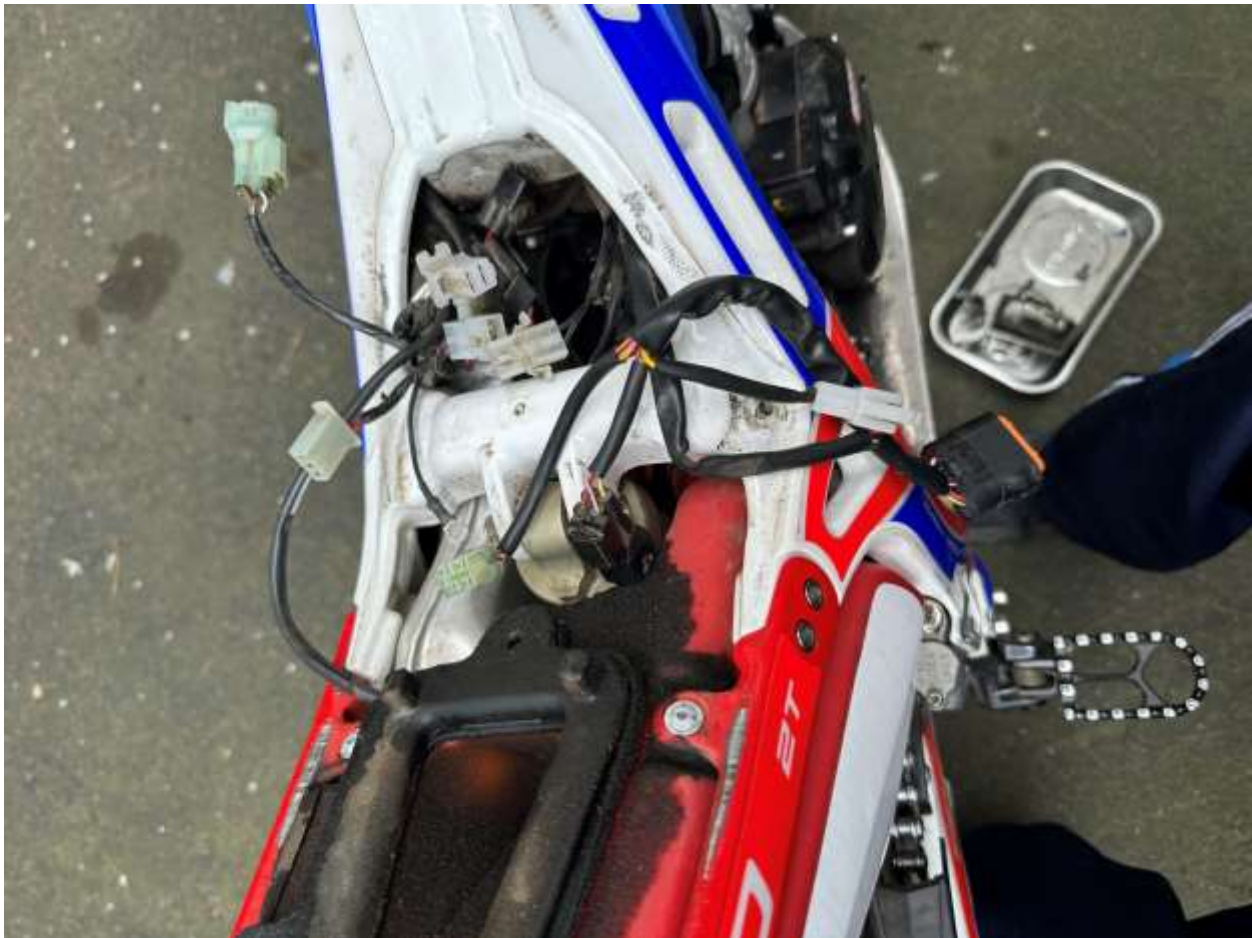
The CDI module is connected via an 18-Pin automotive connector (JAE Electronics MX23A type if you're interested). Coming from the stator are the two trigger sensor wires and the two high voltage CDI charge wires to the CDI, the two wires from the lighting coils do not connect to the CDI but go directly to the Regulator/Rectifier under the headlight. Coming from the CDI connector and splitting off from the harness is a four wire connector that includes a wire that goes to the ground nexus, the wire that goes to the mapping switch, the wire that goes to the Kill switch and the high-voltage primary ignition wire that goes to the ignition coil. To the 18 pin CDI connector is another four wire connector with the 12Vdc from the Regulator/Rectifier output and three wires that are dead ended at the connector These are the "Engine Fault" wire and the two OBD wires.

Figure 6 Bar puzzle of connectors. Good luck
